FILAMENT-WOUND KEVLAR 49/EPOXY PRESSURE VESSELS

November 9, 1973

**LAWRENCE
LIVERMORE
LABORATORY**

NASA-LEWIS RESEARCH CENTER
CONTRACT C-13980-C
R. F. LARK, PROJECT MANAGER

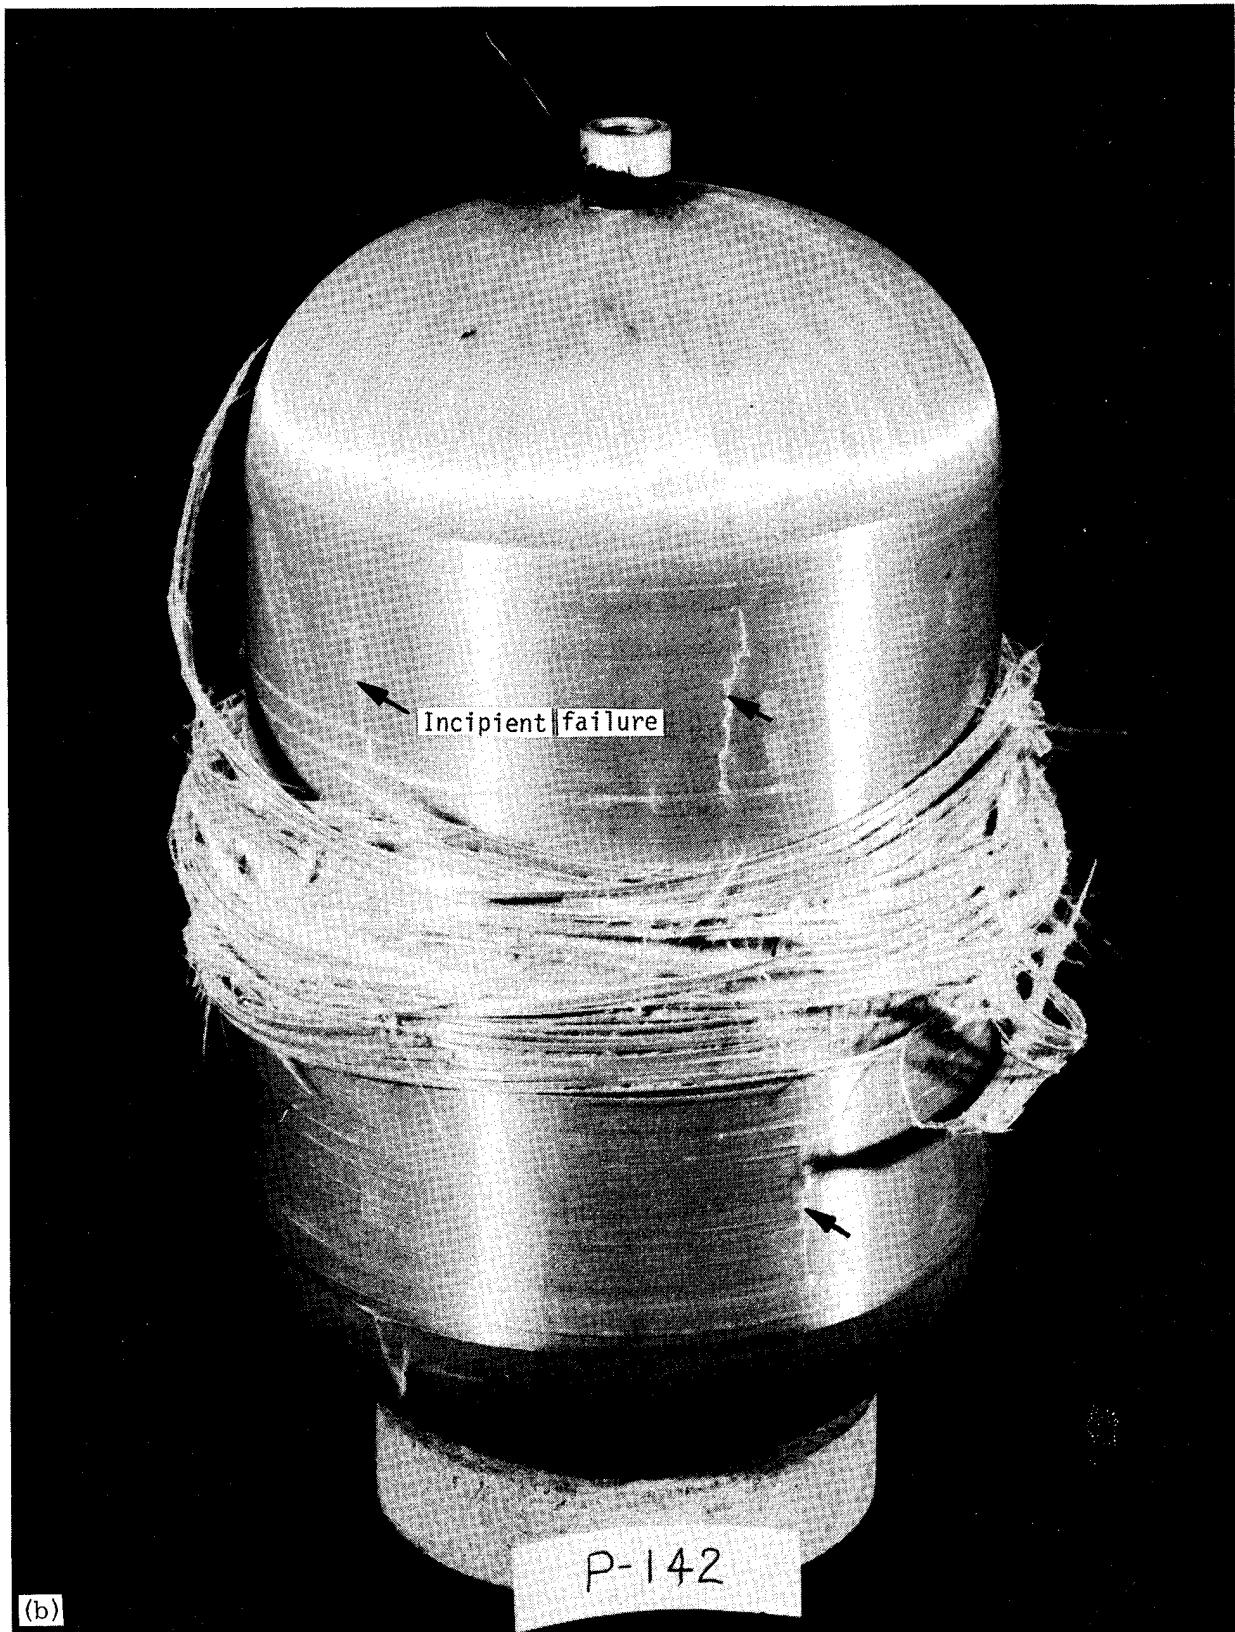
Fig. 31. Vessel failure; (a) burst of 2.0-mm Al-lined sphere at LH_2 temperature, (b) burst of 0.5-mm rubber-lined cylindrical vessel at 21°C .

cylindrical and spherical vessels. In the case of 2.0-mm aluminum-lined spherical vessels, the single value burst pressure at LH_2 [failure shown in Fig. 31(a)] is about 11% higher than the average burst value at 21°C . This value seems statistically significant; however, we attribute the bulk of this difference to the contribution of 2.0-mm aluminum liner. The increase in
